Total Home Inspections Inspection Report

LOCATED AT:
60 Goldmont Street
Black Mountain, North Carolina 28711

INSPECTED ON:
Tuesday, January 23, 2024

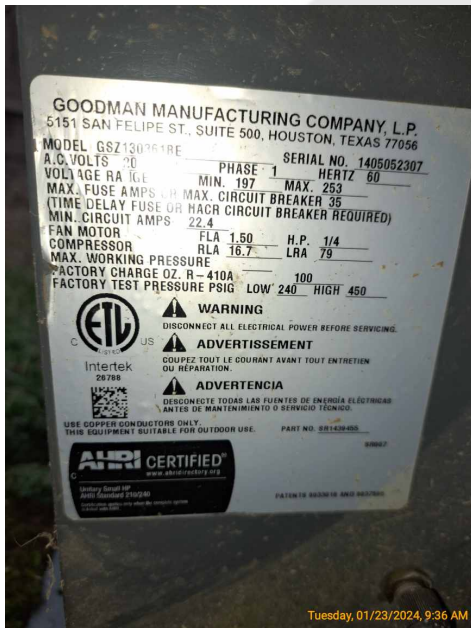
5: Model: GSZ130361BE

6: Operating an air condition system in cold weather can damage the compressor. The outside air temperature was determined to be too low for the safe operation of the equipment. We recommend inspection of the system with the return of warmer weather.

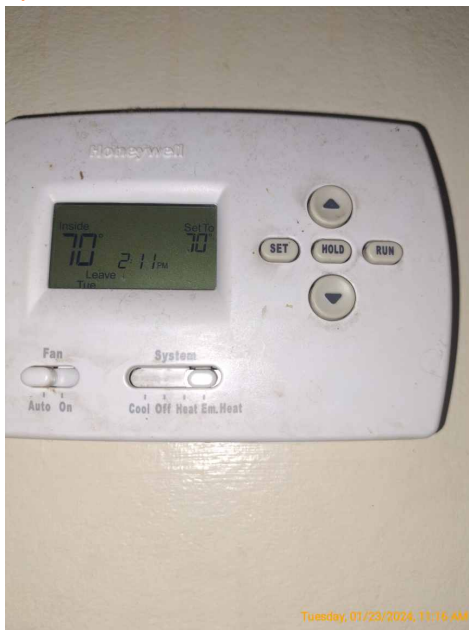
8: The unit responded to the thermostat and it is generally properly installed, with exceptions noted below. The thermostat was set to emergency heat. we recommend having an HVAC contractor evaluate the system for proper operation.

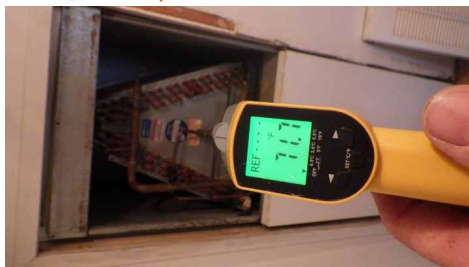
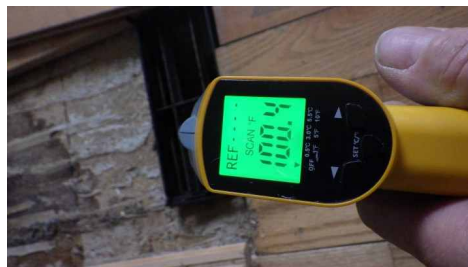
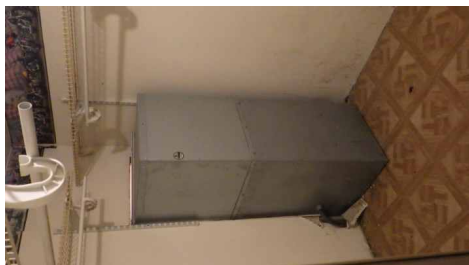
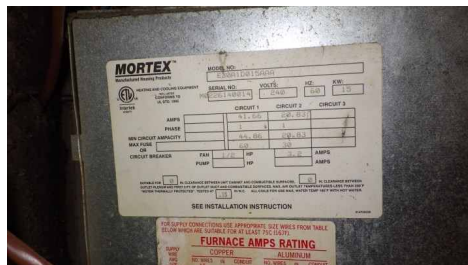
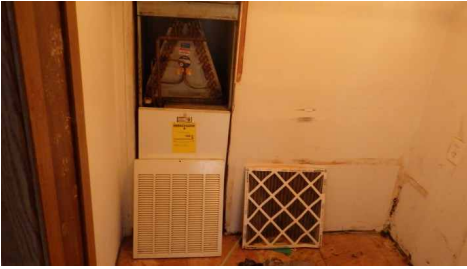
9: This heating interior unit is beyond its expected service life. Although still operating, the need for replacement should be expected in the near future.

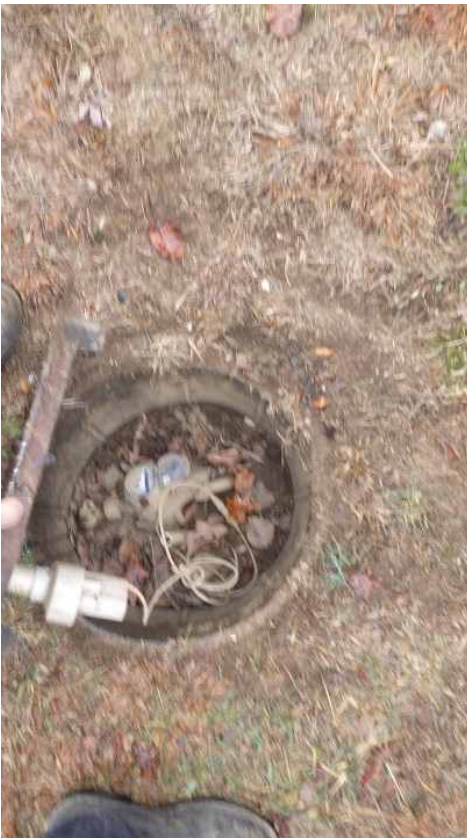
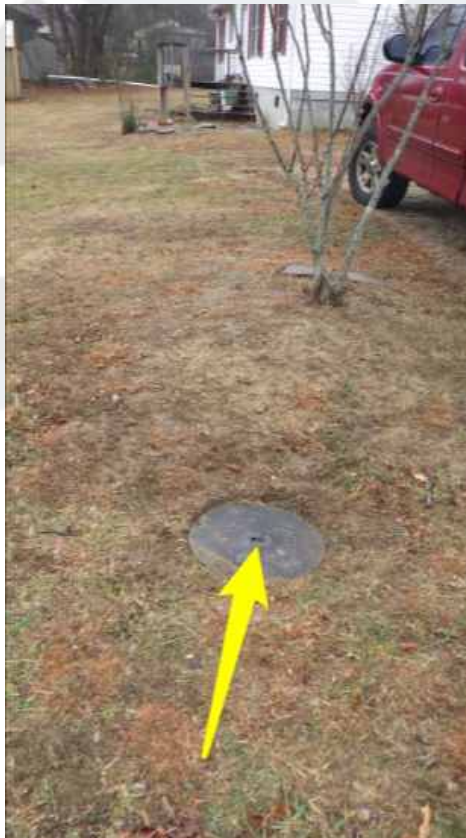
16: The domestic water supply main shut-off valve is located at manhole by the road.

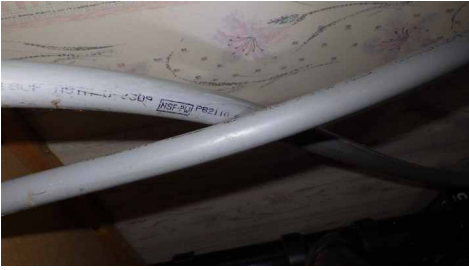
17: The water piping in this house is a polybutylene material which was an accepted and permitted material at the time of installation. Problems with this type of system have developed in many areas. Chlorine in municipal water systems deteriorates the pipe from the inside. We recommend having the system evaluated by a qualified plumber.

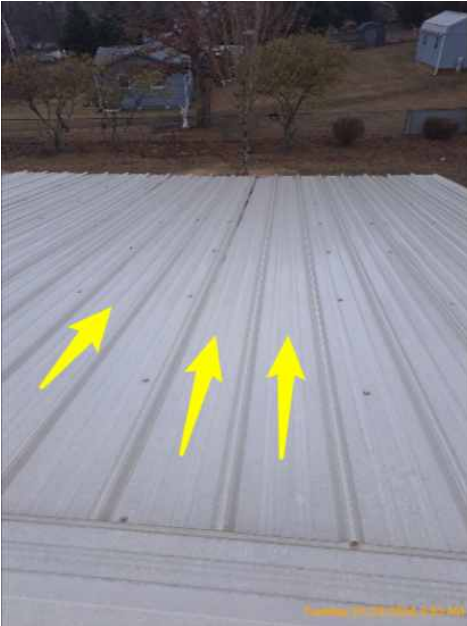
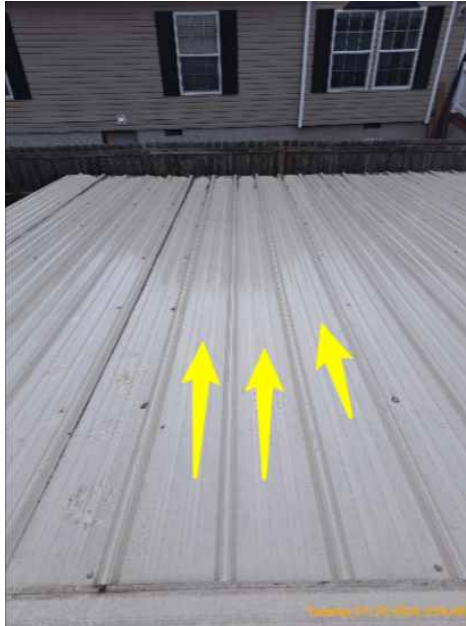
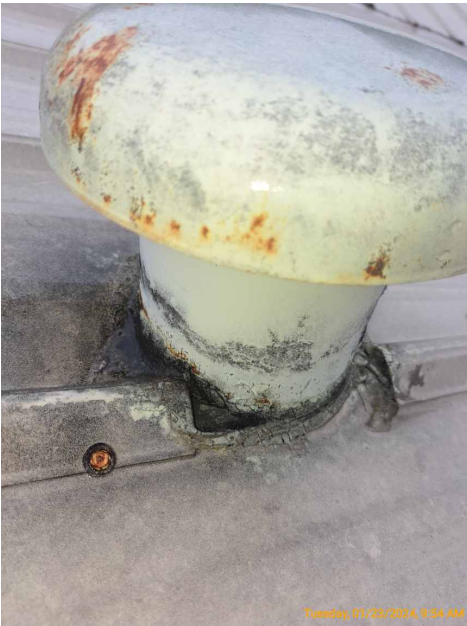
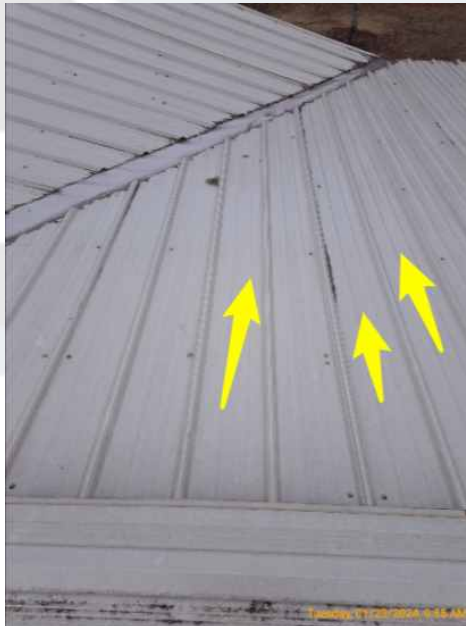
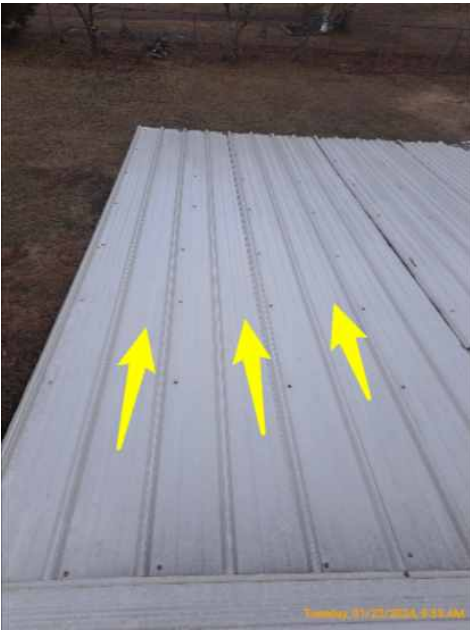
23: The roof is in satisfactory condition. Attention to the items noted above, together with routine maintenance will maximize its useful life. The kitchen hood vent penetration needs resealing. Some panels of the roof appear to be lacking fastener's which could result in loose metal being blown off. we recommend services of a roofing contractor to repair these issues.

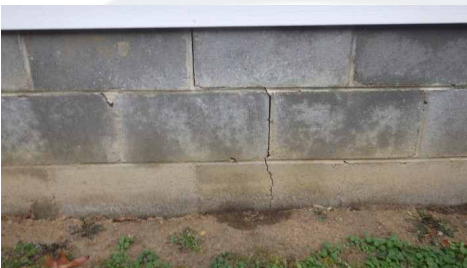
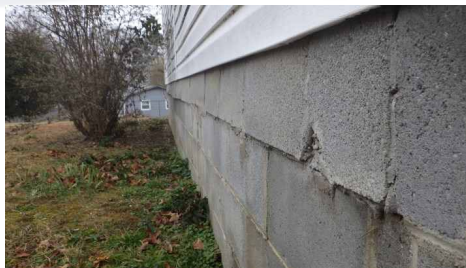
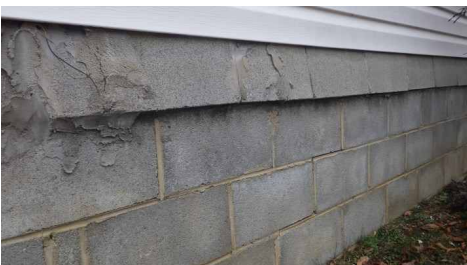
28: Hairline and/or small cracks, within normal tolerances, are visible. This type of cracking is often a result of shrinkage of materials and/or minor settlement and usually does not affect the strength of the foundation. There are also uneven blocks on the top course of the perimeter wall in driveway side. monitor cracks for future movement. The home is supported by piers underneath the home. The block is not load bearing or structural. Repair of offset block would be for aesthetic purposes.

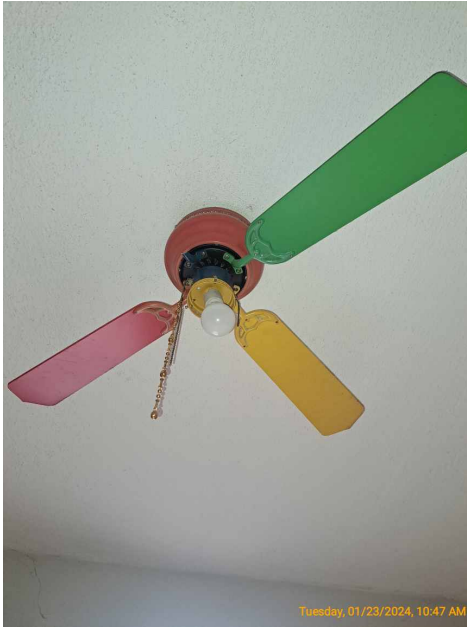
29: The {FillHere} light fixture is damaged. We recommend it be repaired or replaced.

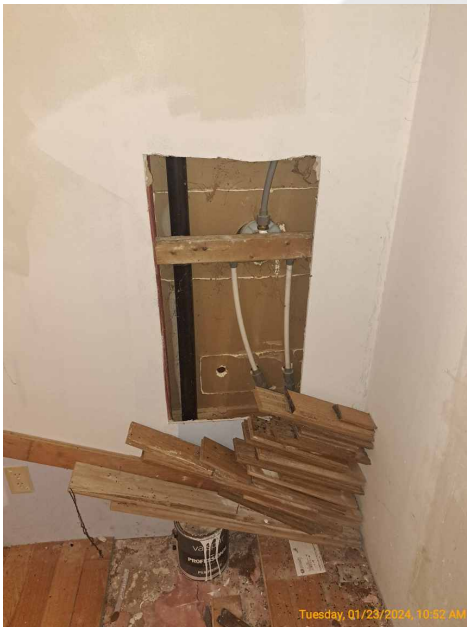
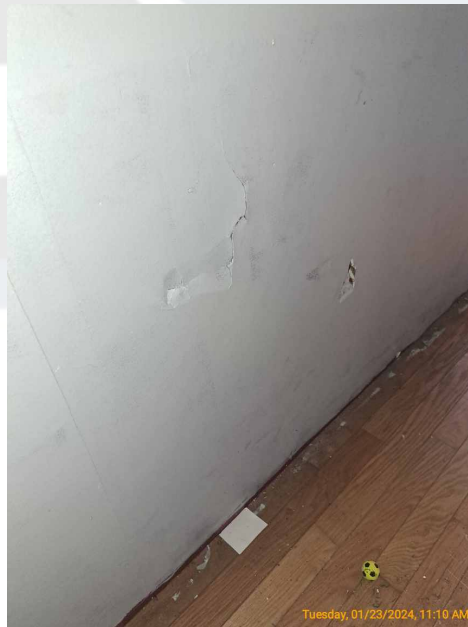
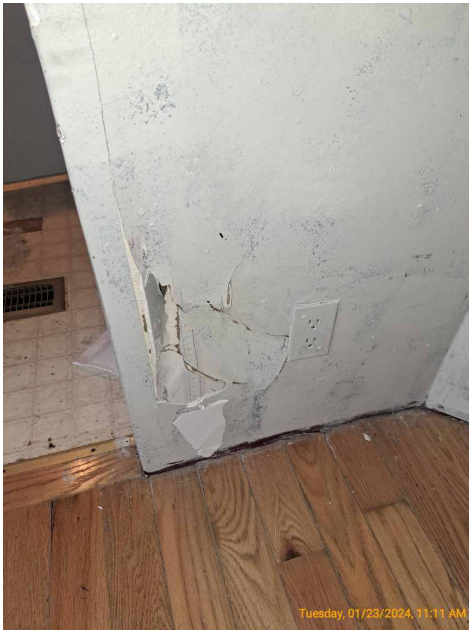
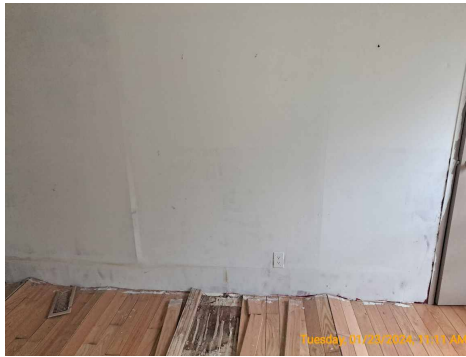
30: The walls are damaged at the back bedroom. We recommend repair or refinishing.

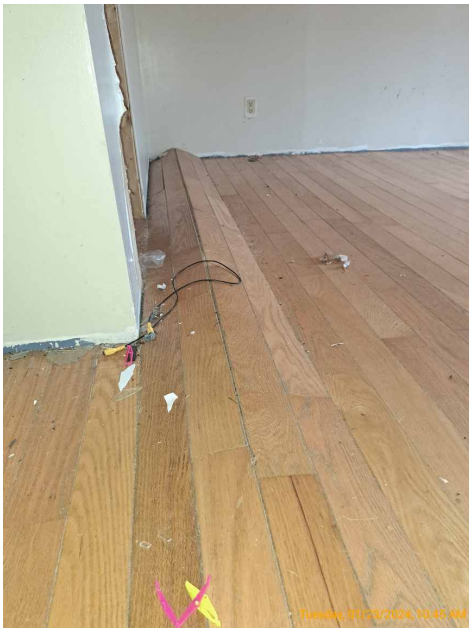
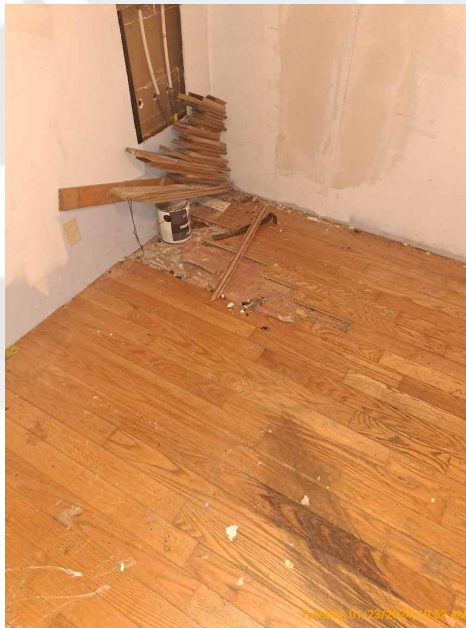
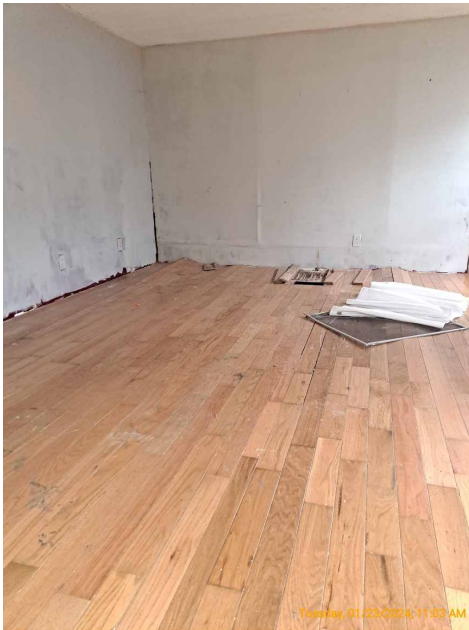
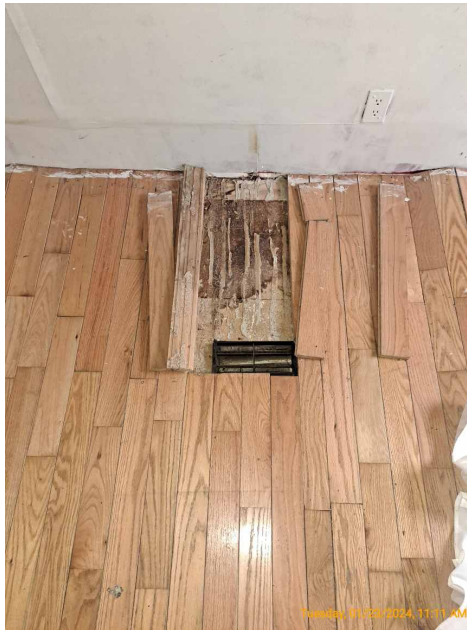
31: There is damaged/buckled flooring throughout house. We recommend the source of the damage be identified and corrected, and the surfaces then be prepared and refinished to restore appearances.

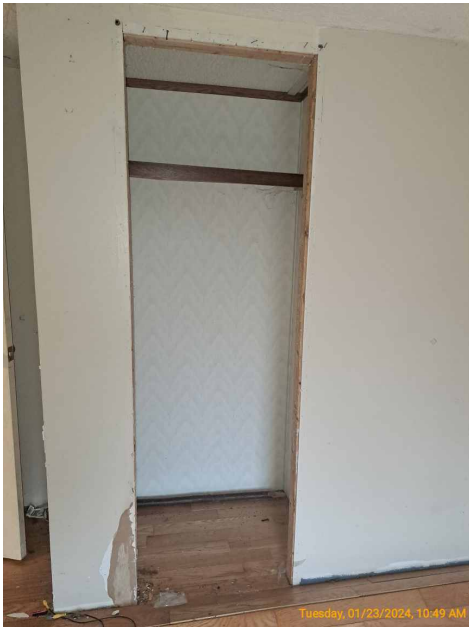
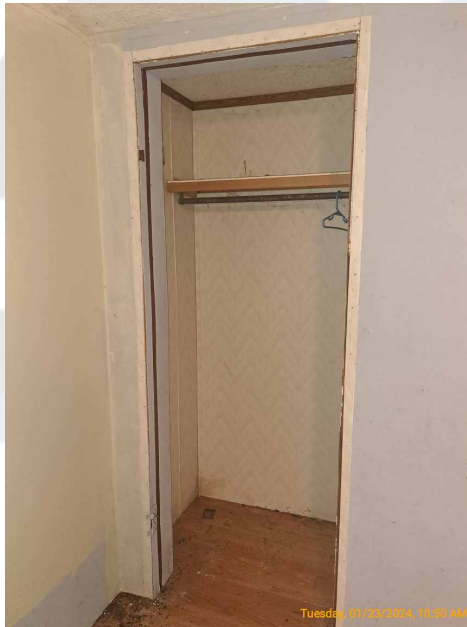
32: One or more doors have removed in front bedroom closet.

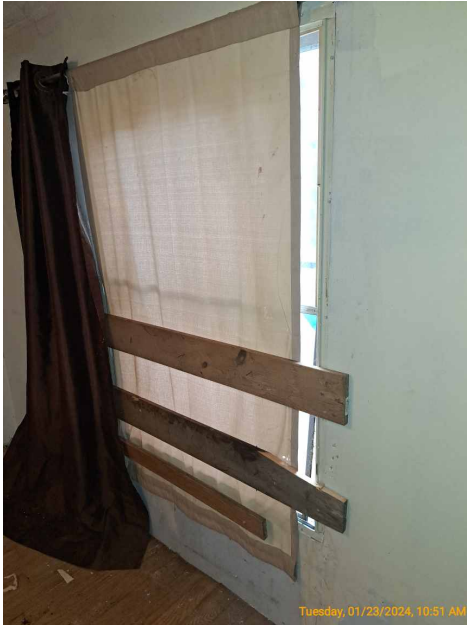
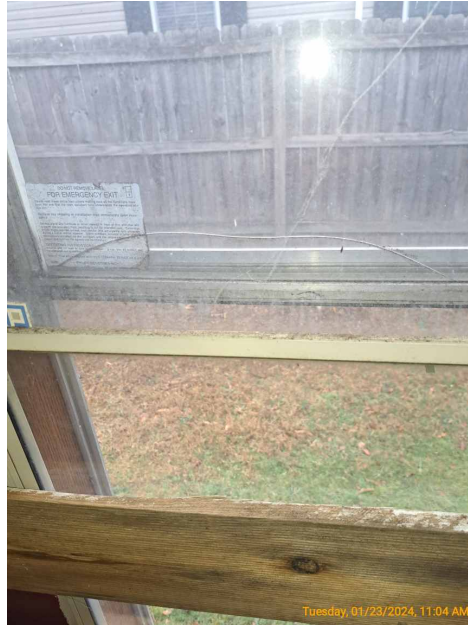
33: One or more panes of glass are broken in back bedroom. We recommend all broken glass be replaced.

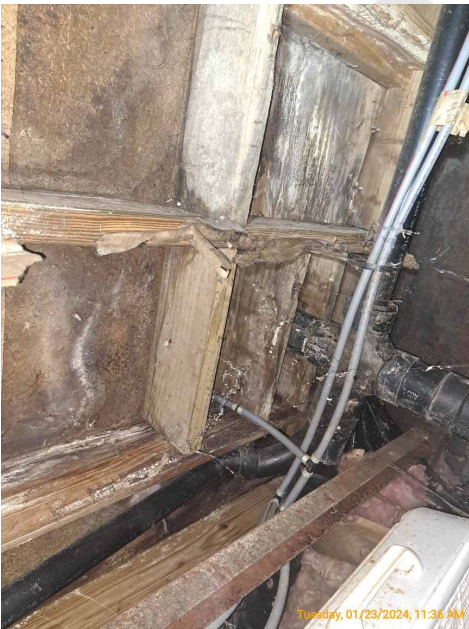
36: Generally, the subflooring is in good condition. However, the subfloor beneath the shower stall is damaged. We recommend the subflooring be repaired and all damaged material replaced.

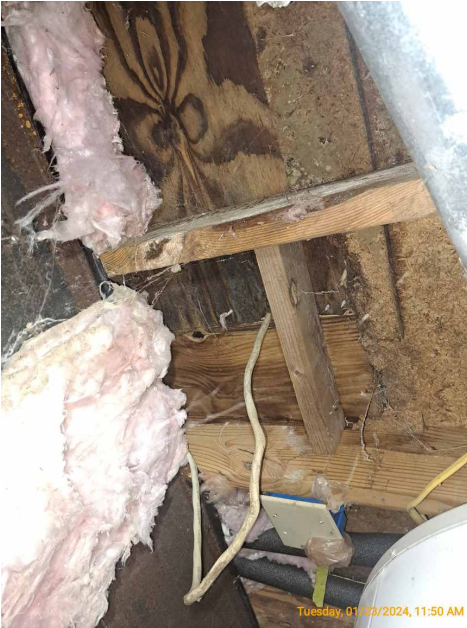
37: Generally, the subflooring is in good condition. However, the subfloor beneath the washer is damaged. We recommend the subflooring be repaired and all damaged material replaced.

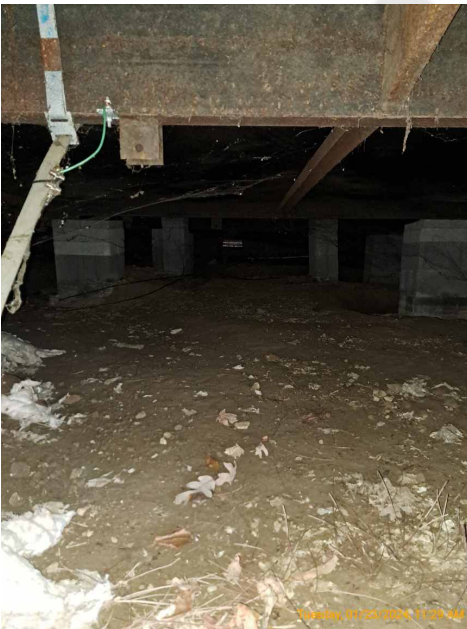
38: There is no vapor barrier in place in this crawl space. A vapor barrier is considered a beneficial feature and we recommend one be installed.

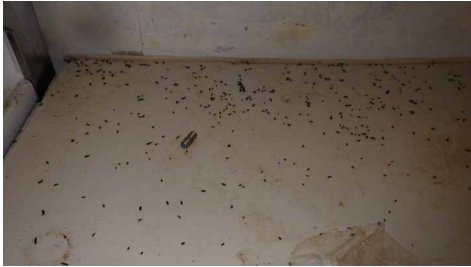
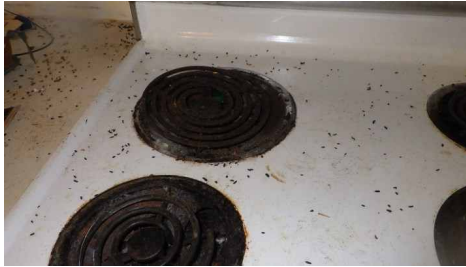
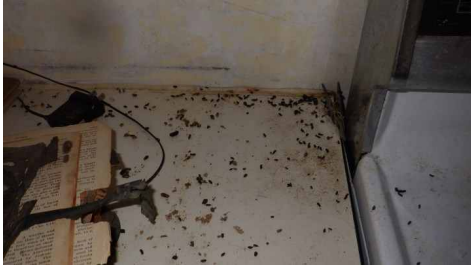
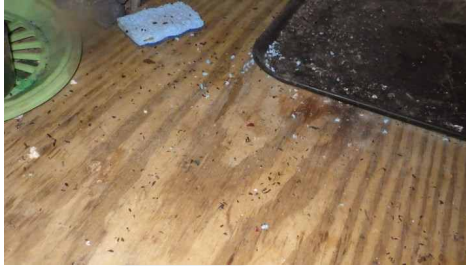
39: Rodents have been active in the past. We recommend that bait or traps be set and monitored. The advice and services of a licensed exterminator would be recommended if problems persist.

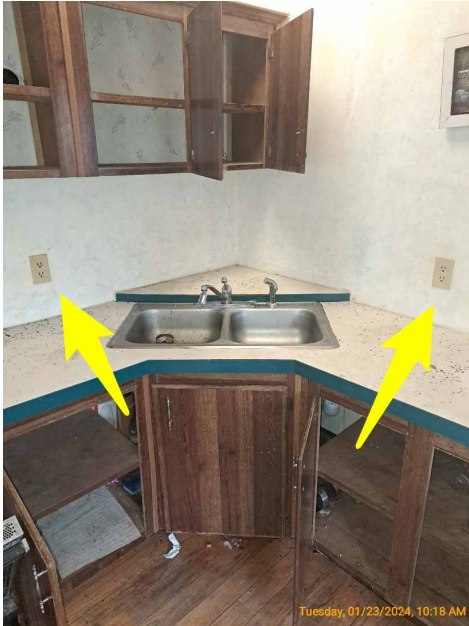
42: There is no GFCI (ground fault circuit interrupter) protection for the countertop receptacle(s) within six feet of the sink. For an increased margin of safety, we recommend the installation of a GFCI receptacle(s).

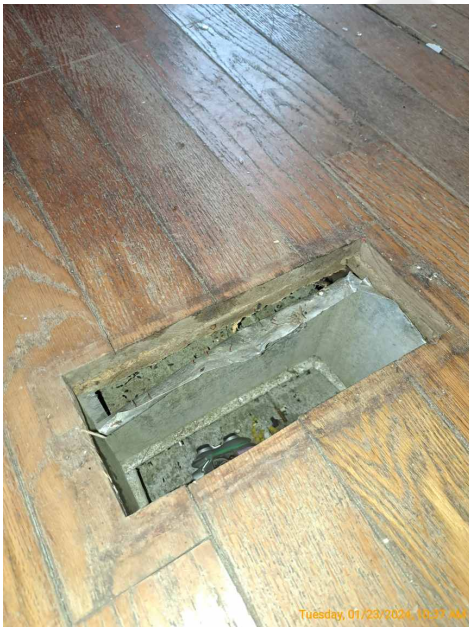
43: The heating outlet is damaged. We recommend it be replaced.

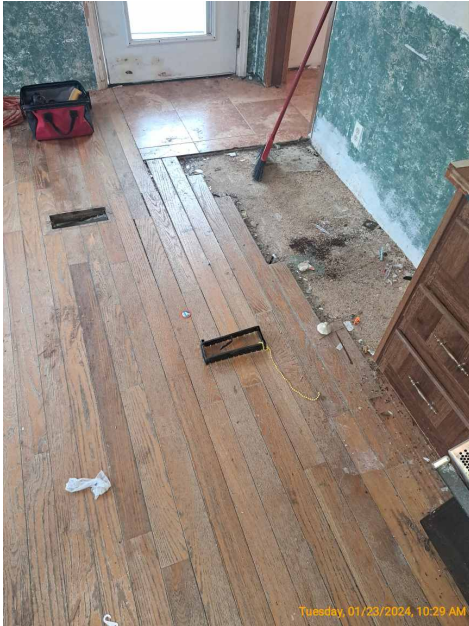
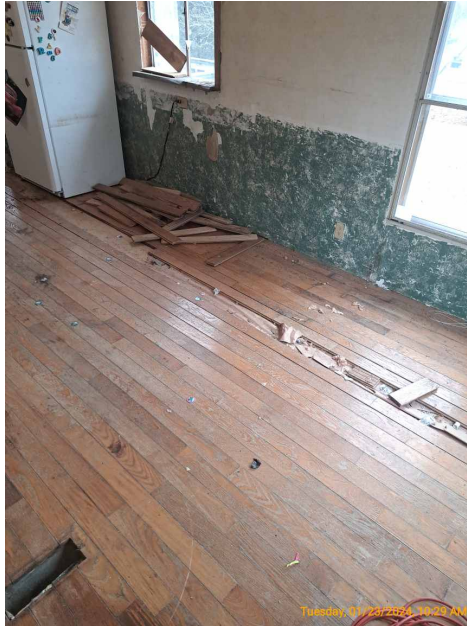
44: There is damaged/buckled flooring. We recommend the source of the damage be identified and corrected, and the surfaces then be prepared and refinished to restore appearances.

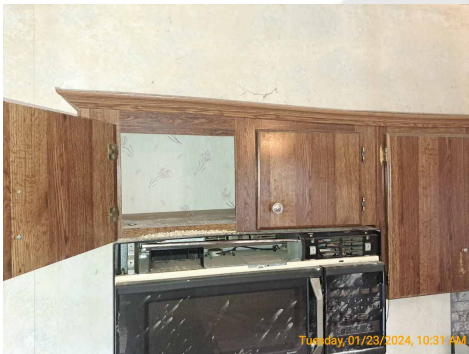
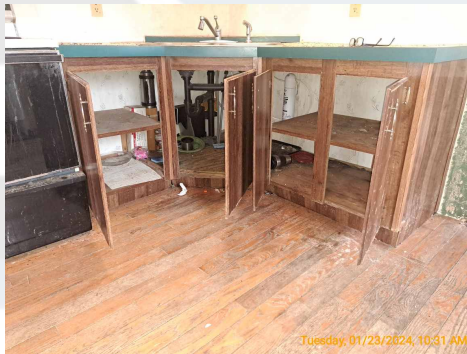
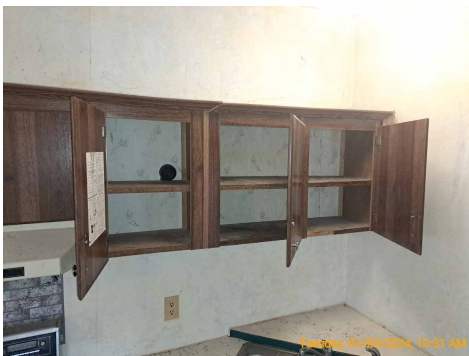
45: The cabinets are deteriorated/damaged. This would include loose hinges and/or track glides damaged drawers/doors and worn finish surfaces. We recommend they be repaired or replaced.

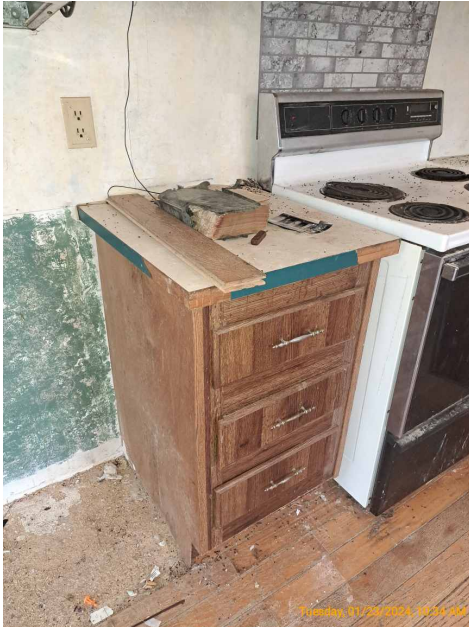
47: The countertop is damaged. We recommend it be replaced.

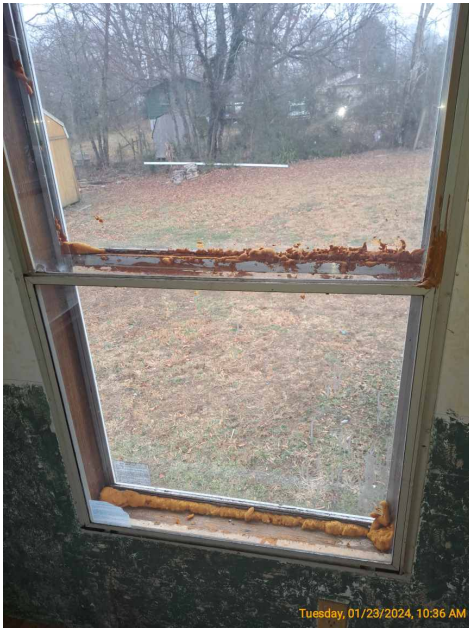
48: One window is stuck or has been sealed shut and cannot be opened. We recommend repair to restore functional use.

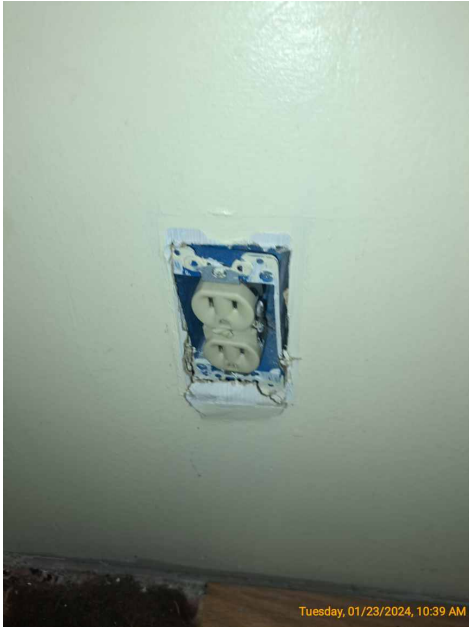
50: A receptacle at the front door is damaged. We recommend it be replaced.

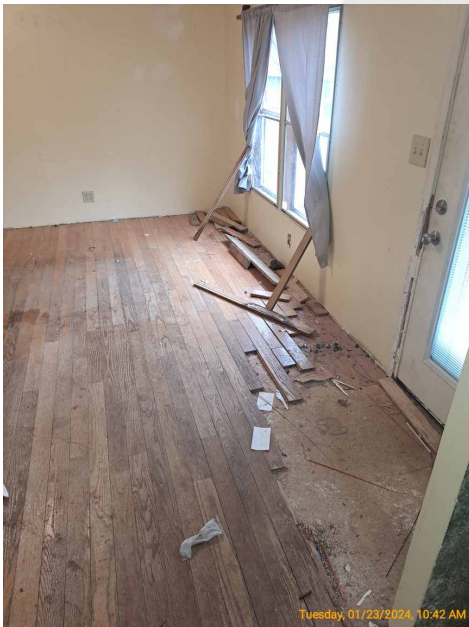
51: There is damaged/buckled flooring. We recommend repair/replacement

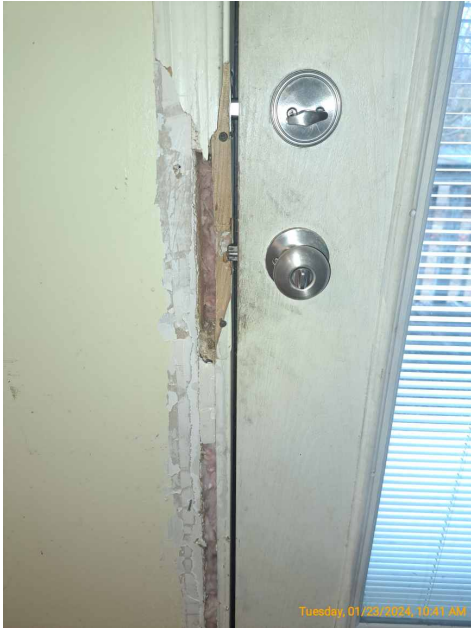
52: The front door frame is broken. We recommend it be replaced.
