Total Home Inspections Inspection Report

LOCATED AT:
60 Goldmont Street
Black Mountain, North Carolina 28711

INSPECTED ON:
Tuesday, January 23, 2024

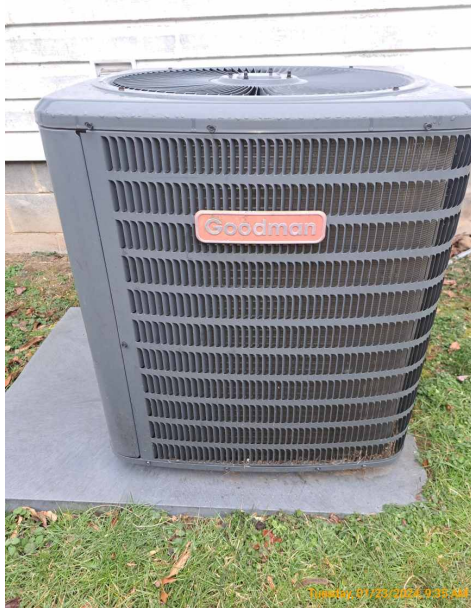
4: Manufacturer: Goodman

5: Model: GSZ130361BE

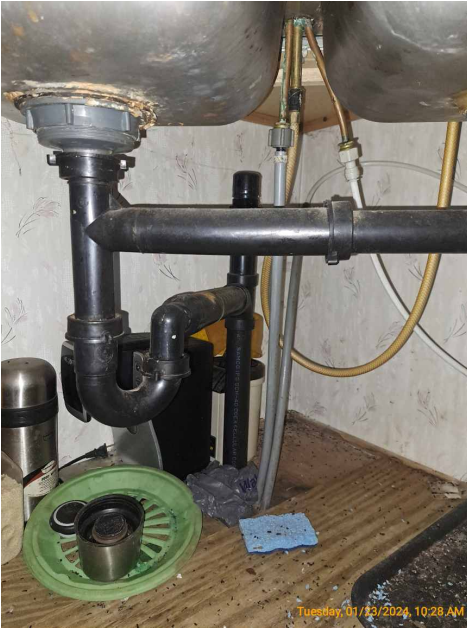
15: Waste piping: Plastic where seen

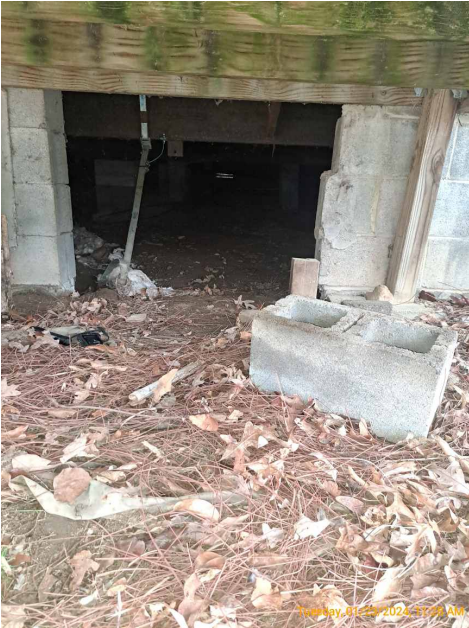
36: Generally, the subflooring is in good condition. However, the subfloor beneath the shower stall is damaged. We recommend the subflooring be repaired and all damaged material replaced.

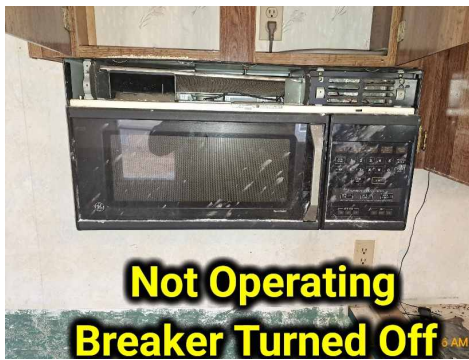
41: Ventilation: Exhaust ducted to the exterior

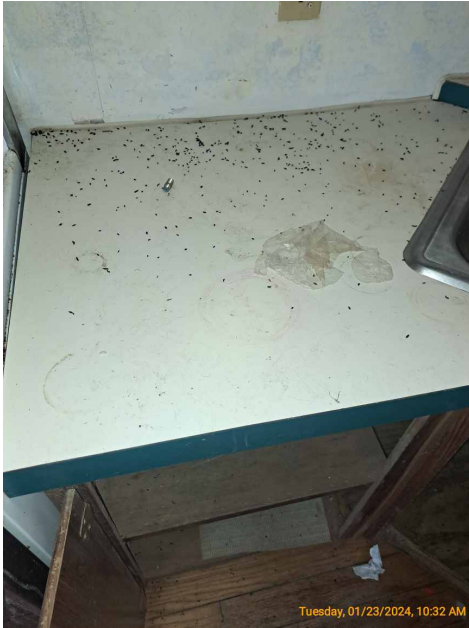
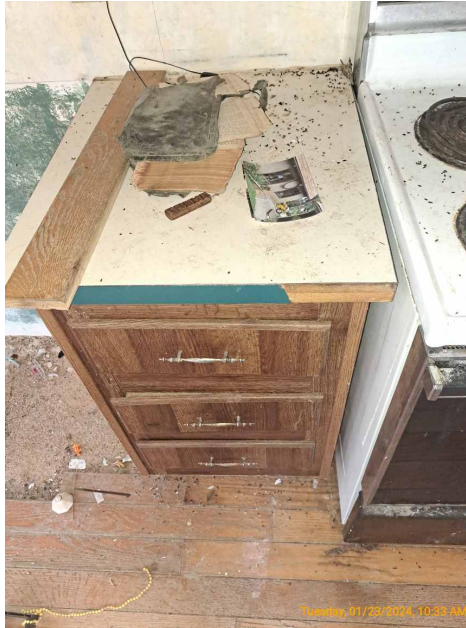
47: The countertop is damaged. We recommend it be replaced.

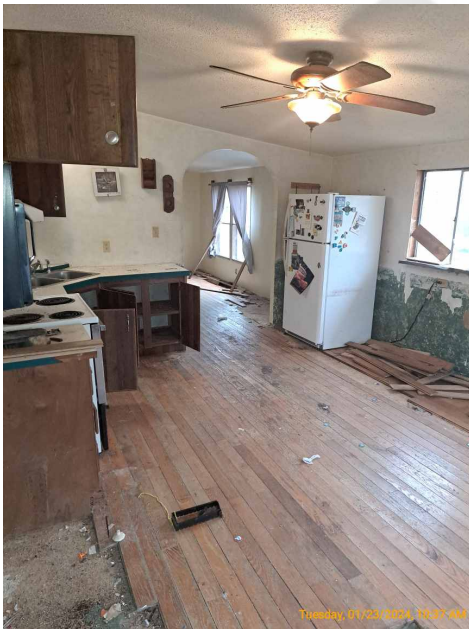
49: This area is in need of repair as noted above or in other sections of this report.

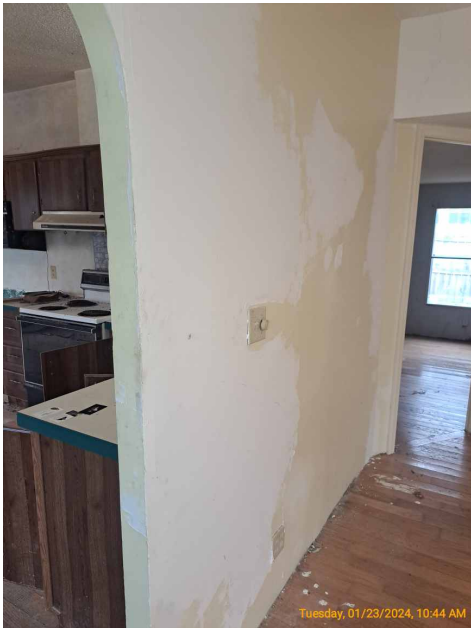
53: This area is in need of repair as noted above or in other sections of this report.
